Client Success Story - 2017

The following is a description of an actual project completed in 2016 where RCP was deployed onsite to validate a pressure test using TestOp. This case study was presented in conjunction with the Operator representative at the AGA Transmission Integrity Management Workshop in Pittsburg this past May 2017.

Pressure Test Details

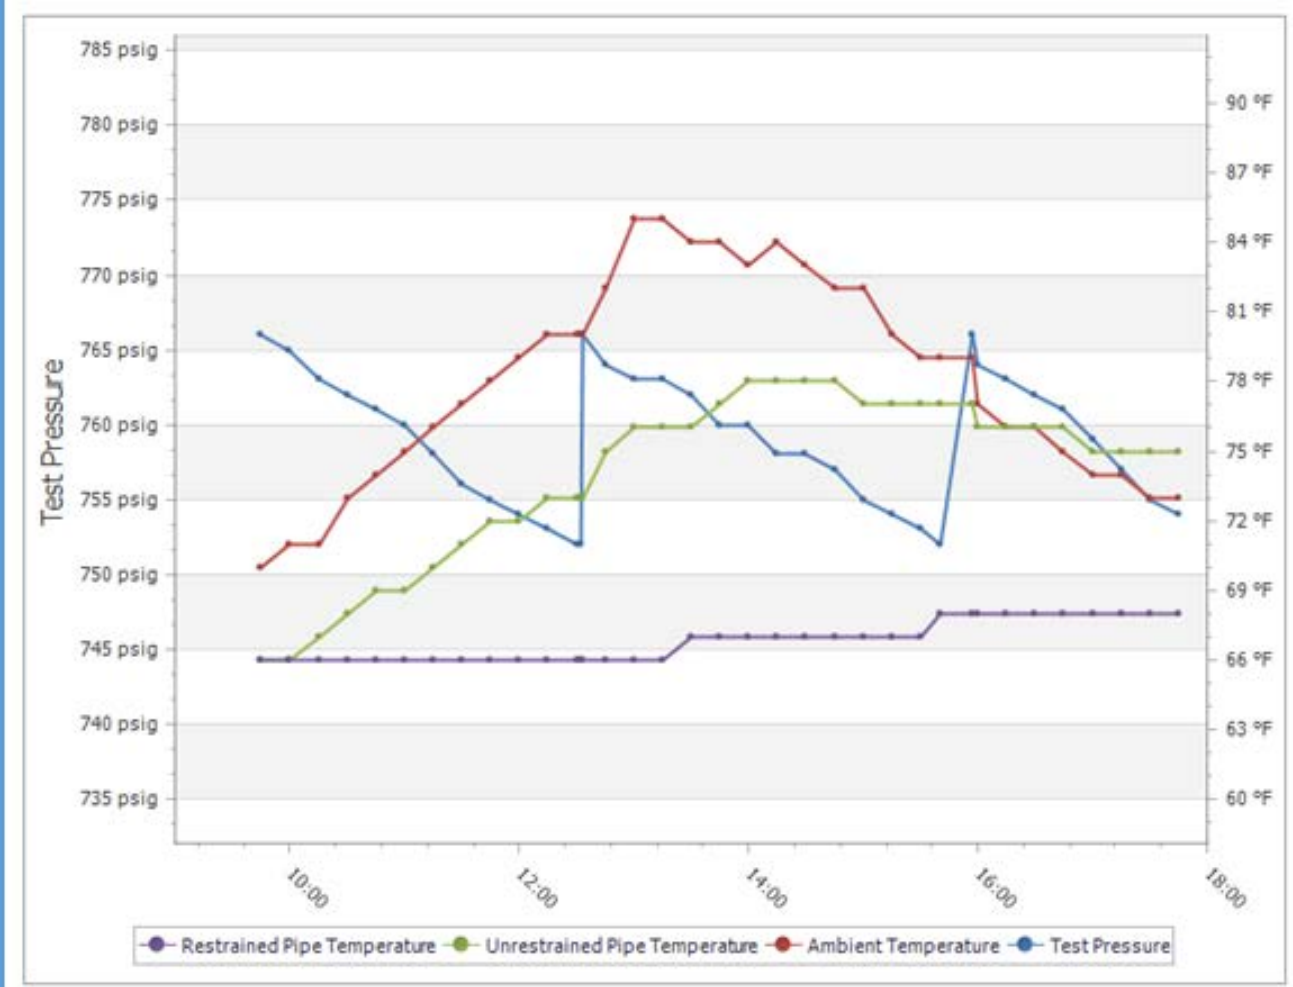
Hydrotest Attempt #1

0 Hours: 766 psig, 66°
 8 Hours: 754 psig, 68°
 Injected water 2 times to maintain test pressure

Allowable Loss	Predicted Loss	Test Good?
<u>TestOp</u>	1.91 gal	9.34 gal	NO
CSFM	10.31 gal	6.35 gal	YES

CSFM = California State Fire Marshal Model, a publicly available mass balance model.

- “Pressure drop was due to a change in temperature.
- When the pressure was lowered from 765 to 600, the pressure held for several hours.
- Maybe accurate temps weren’t recorded and the probes are in the wrong spot?”

- “Per TestOp, the test was an obvious failure.
- The temperature went up... so pressure should have also gone up, NOT down.
- It’s common for small defects to only leak at higher pressures.”

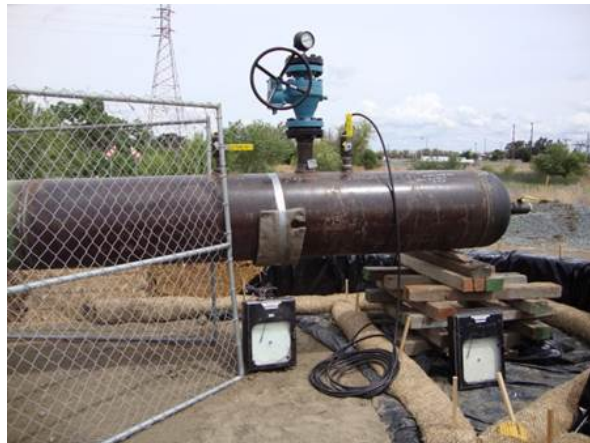
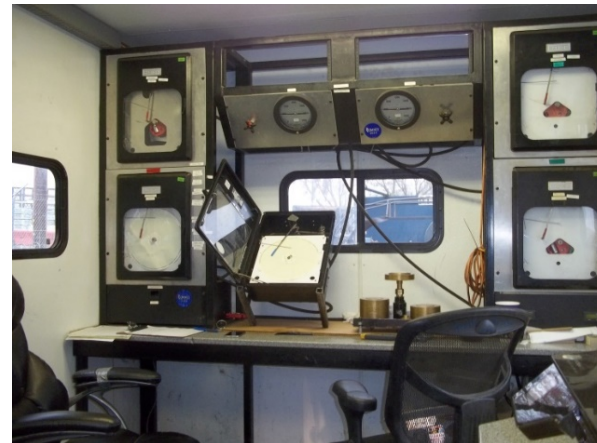
Test #1: What should we do?

- Operator was also concerned about retesting, as they had heard about the potential dangers of pressuring the pipe multiple times.
- Praxair could not detect any leaks.

➔ RCP was able to convince Operator to retest.

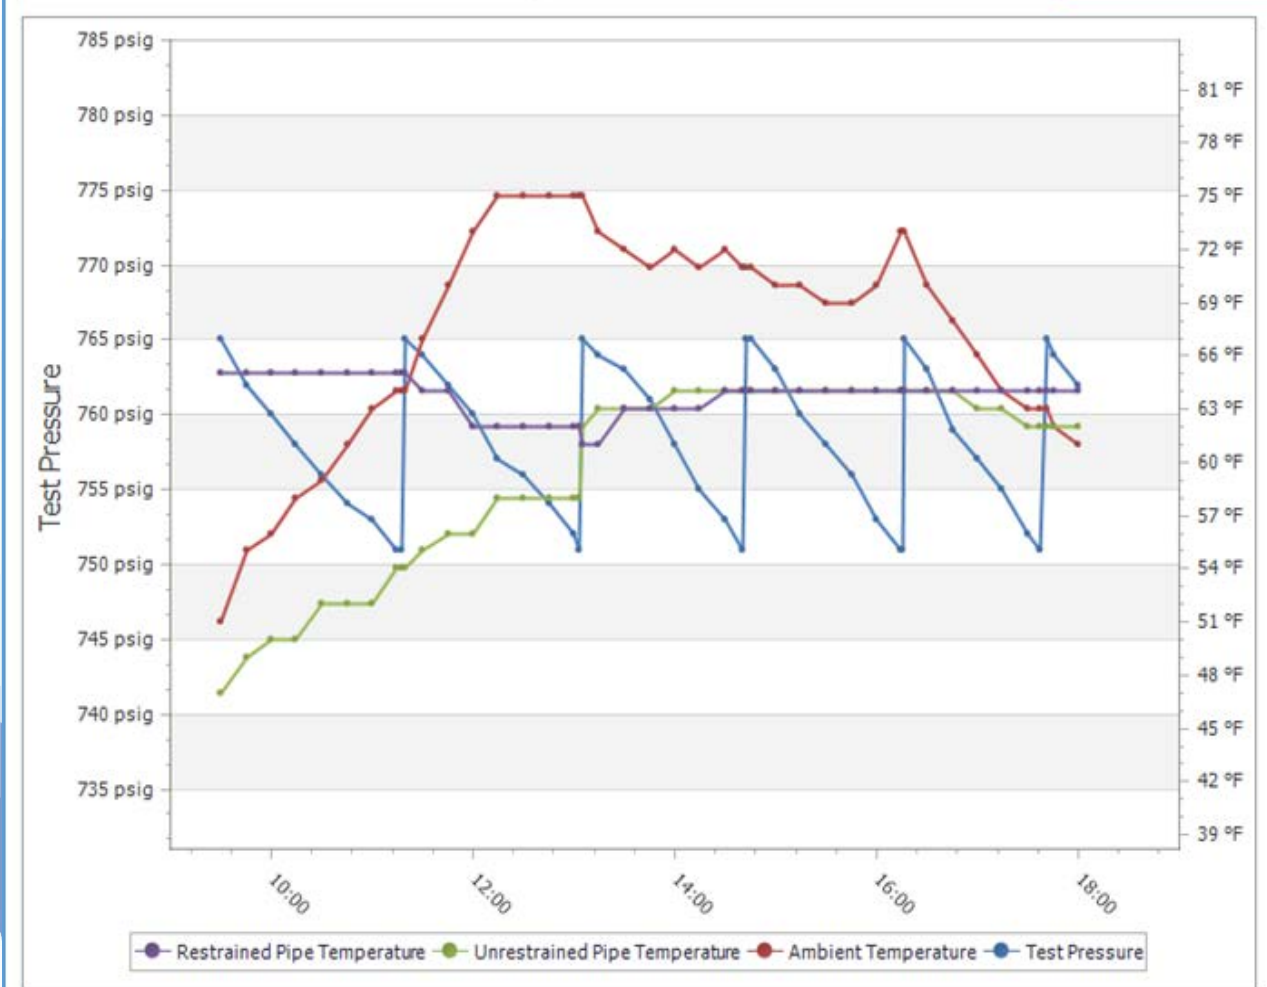
Hydrotest Attempt #2

0 Hours: 765 psig, 65°
 8 Hours: 762 psig, 64°
 Injected water 5 times!

Allowable Loss	Predicted Loss	Test Good?
<u>TestOp</u>	1.75 gal	7.64 gal	NO
CSFM	10.31 gal	6.63 gal	YES

“TestOp clearly shows there is a leak. Let’s leave the pipe at target pressure overnight. Hopefully this will cause enough water to leak from the line that Praxair will be able to detect the leak.”

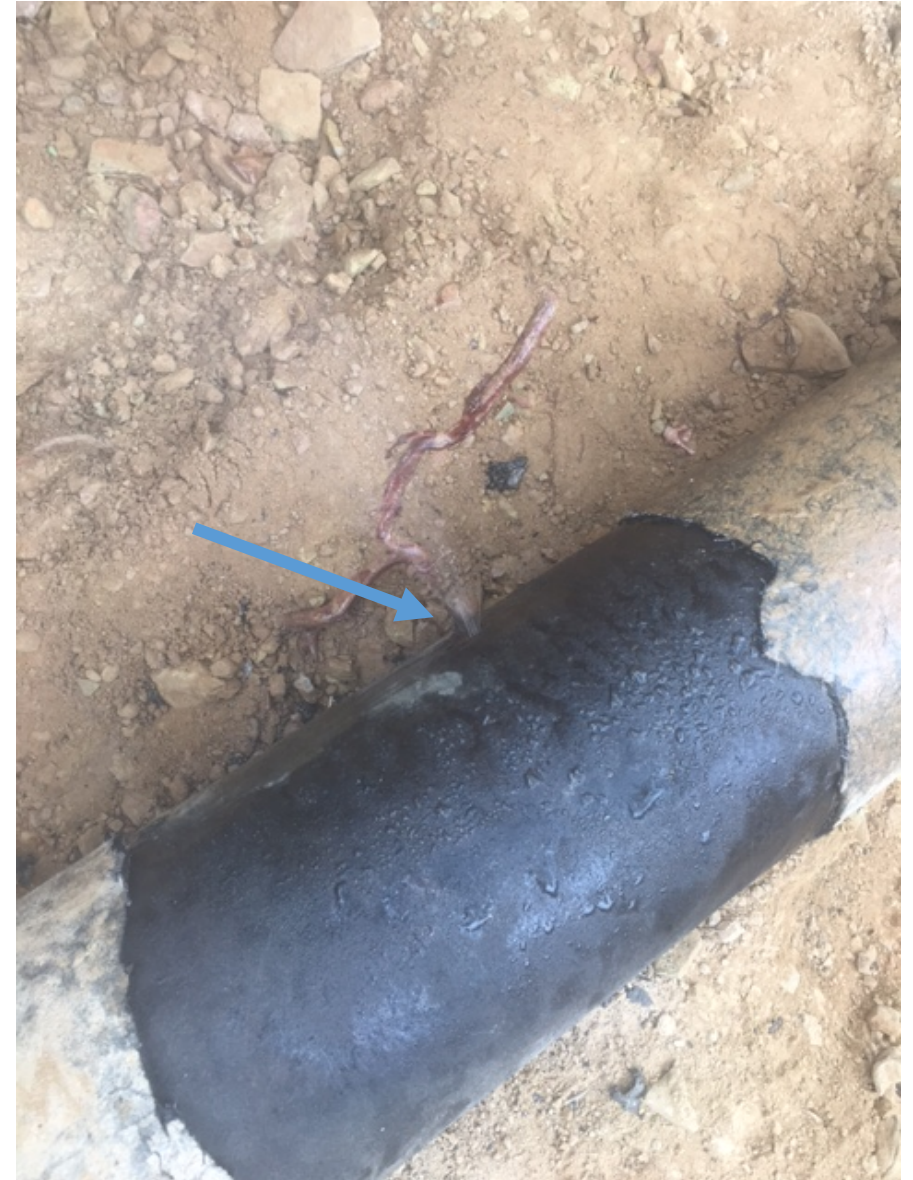
Leak found!

- Test segment lost 125 psi overnight.
- Praxair detected a leak.
- RCP: “Even after the line was exposed there was not a lot of evidence of water. Under low pressure the leak location was not observed until some coating was removed...then you could see the defect location in the long seam with water spraying out of the pipe.”

- The CSFM (California State Fire Marshal) model passed hydrotest attempt #1 and #2. Unless TestOp was deployed, this anomaly would not have been identified during the test.
- Axial MFL is not adequate to detect seam weld defects.
- The combination of ILI, advanced pressure testing technology and material lab sampling of repair cut-outs resulted in integrity verification and provided the necessary assurances to re-establish MAOP on this line and enable the operator to better manage their pipeline safety risks.
